**Contract No. HY/2012/08  
Tuen Mun – Chek Lap Kok Link –  
Northern Connection Sub-sea Tunnel  
Section**

***Detailed Coral Translocation Methodology***

9 October 2013

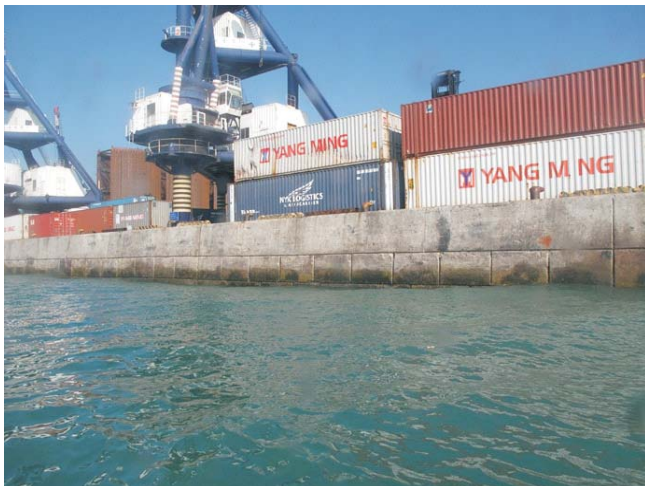
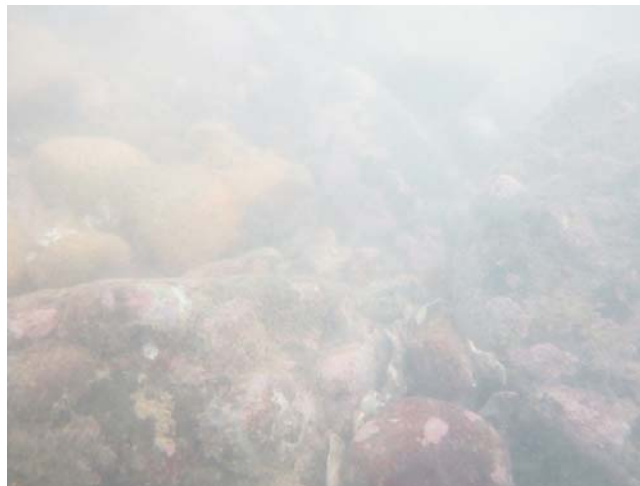
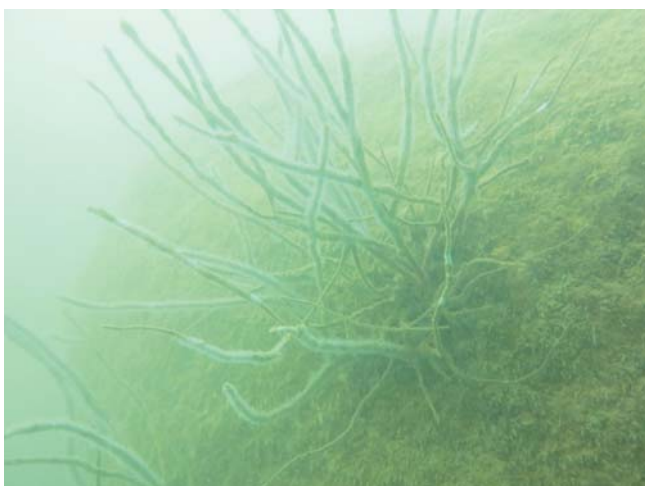
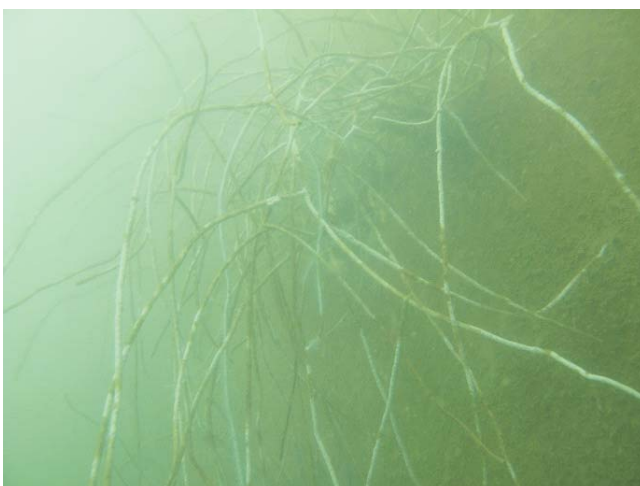
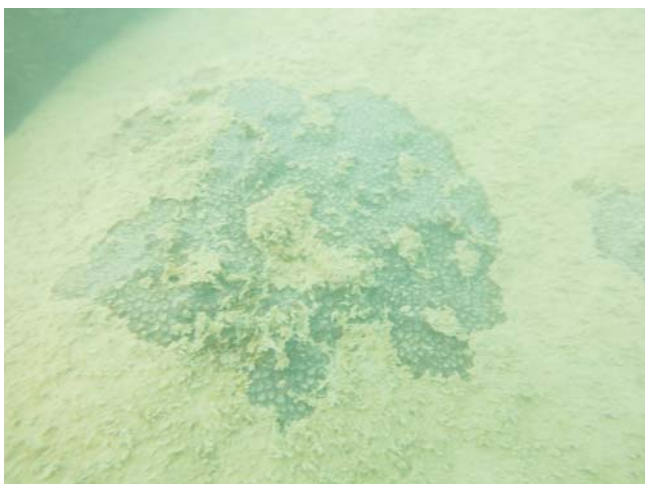
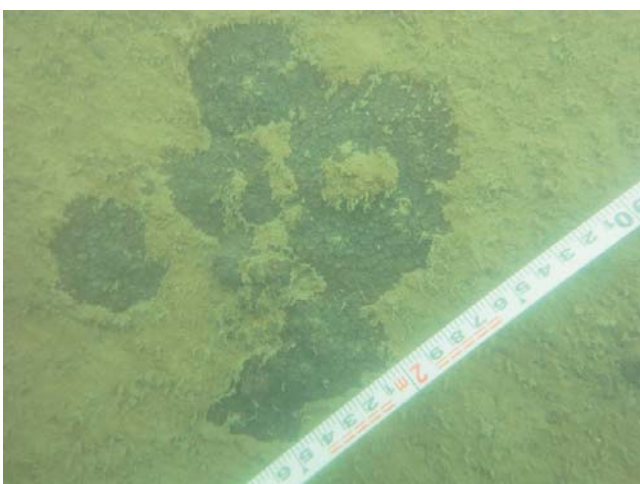
Figure B1

Artificial Vertical Seawall

Natural Bedrocks and Boulders

*Guaiaigorgia sp.*

*Oulastrea crispata*

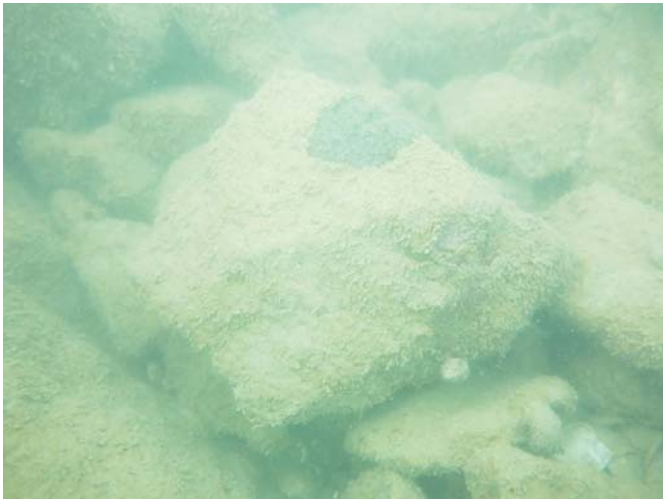
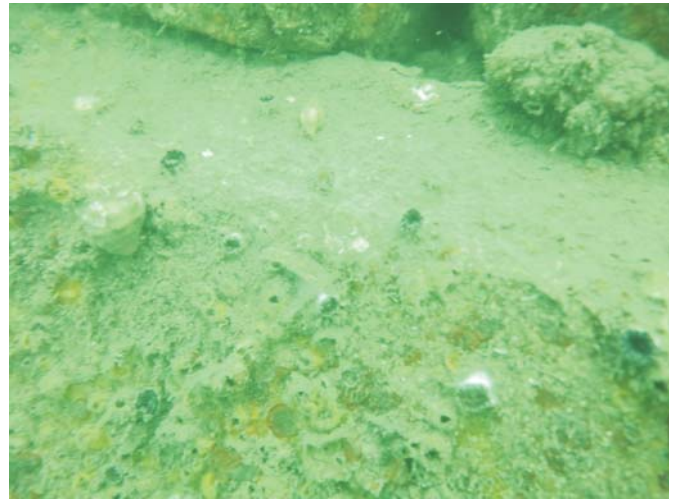
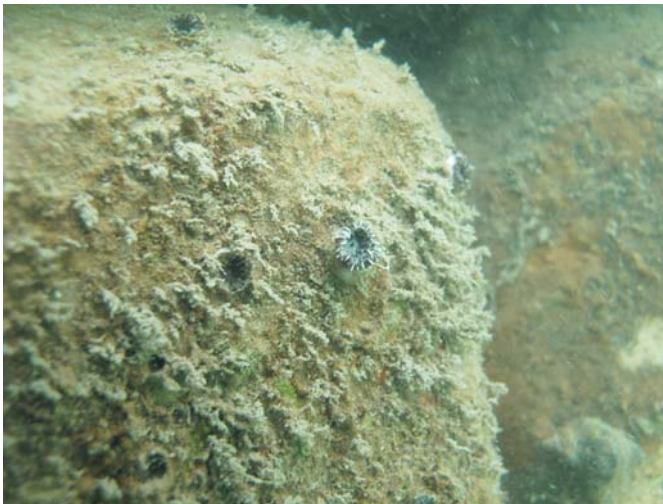
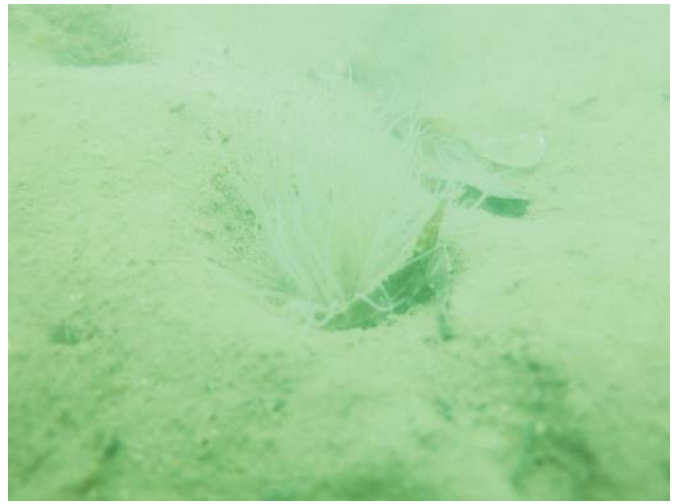
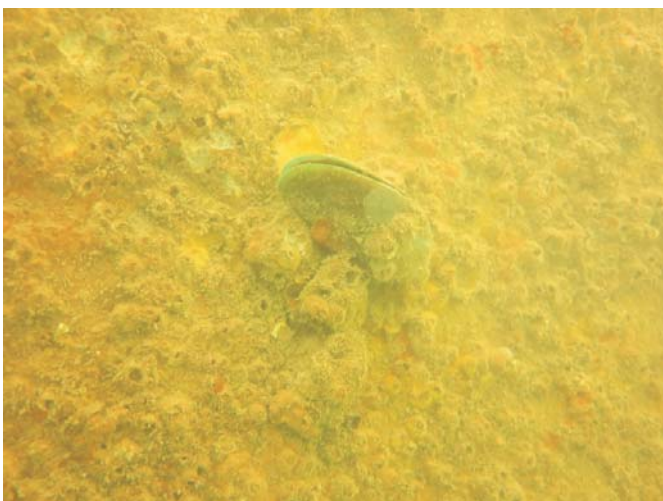
Figure B2

*Oulastrea crispata*

*Balanophyllia* sp.

*Cerianthus filiformis*

*Perma viridis*

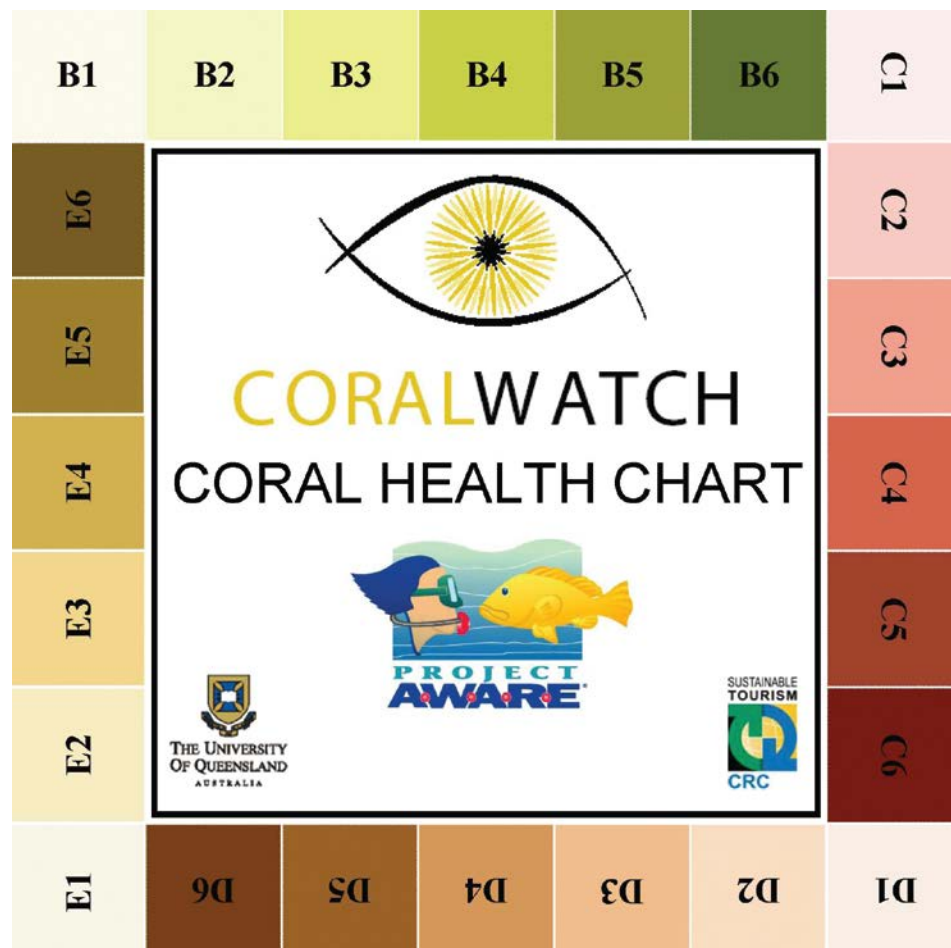
# Coral Health Monitoring Chart

The Coral Health Monitoring Chart has four sample colours and six degrees of darkness (Code 1 to 6) for each sample colour indicating different stages of coral health condition. Code 1 is the lightest (representing bleaching) and Code 6 has the dark colour (representing the healthiest). During the REA survey, the lightest and darkest areas of each coral will be selected, and the colour of areas will be matched to the categories on the chart.
